Analysis of Speed Indicator Device (SID) data for February to April 2024

The SID was located on Somersham Road, facing towards Somersham, for 45 days from February 27th until April 13th. (The SID collects data not only from approaching vehicles but also from those departing in the opposite direction; in the case of departing vehicles the speed is not displayed to the driver.)

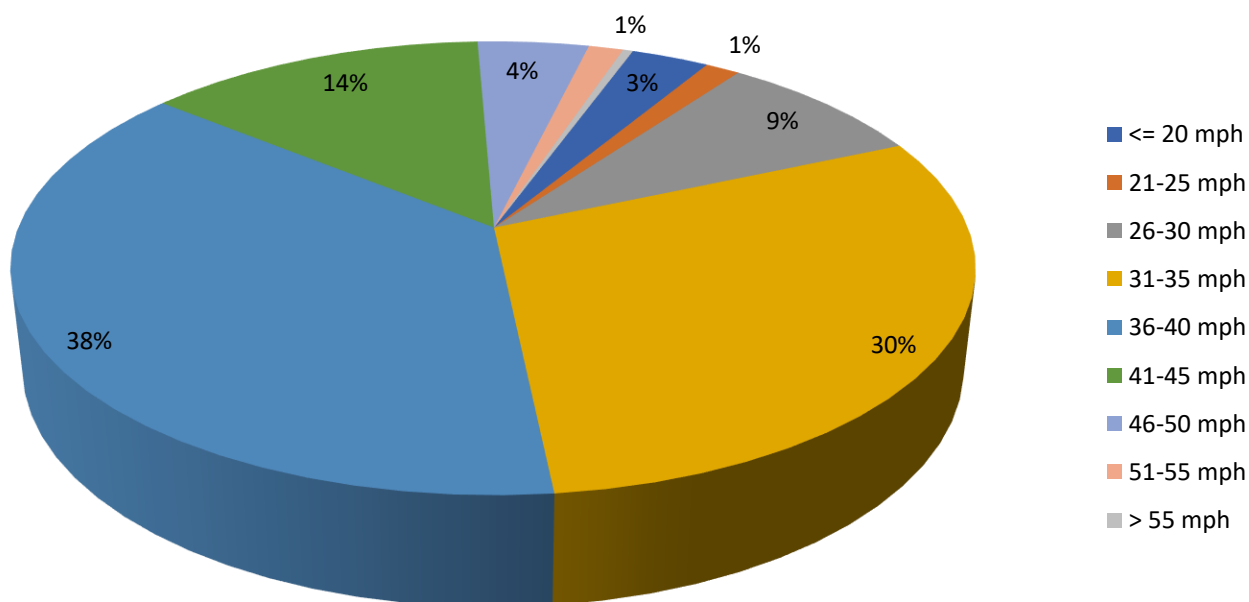
The diagram, below, shows the distribution of vehicle speeds arriving from Somersham:

Vehicles approaching from Somersham

23% of vehicles were recorded as travelling in excess of the 30 mph limit with almost one in six (15%) recorded travelling at a speed greater than 42 mph. The average speed was 37 mph.

These figures represent an improvement on those recorded last June when 27% of vehicles arriving from Somersham exceeded the limit. In December 2022, 25% were recorded as being over the limit. The average speed of vehicles has remained at 37 mph.

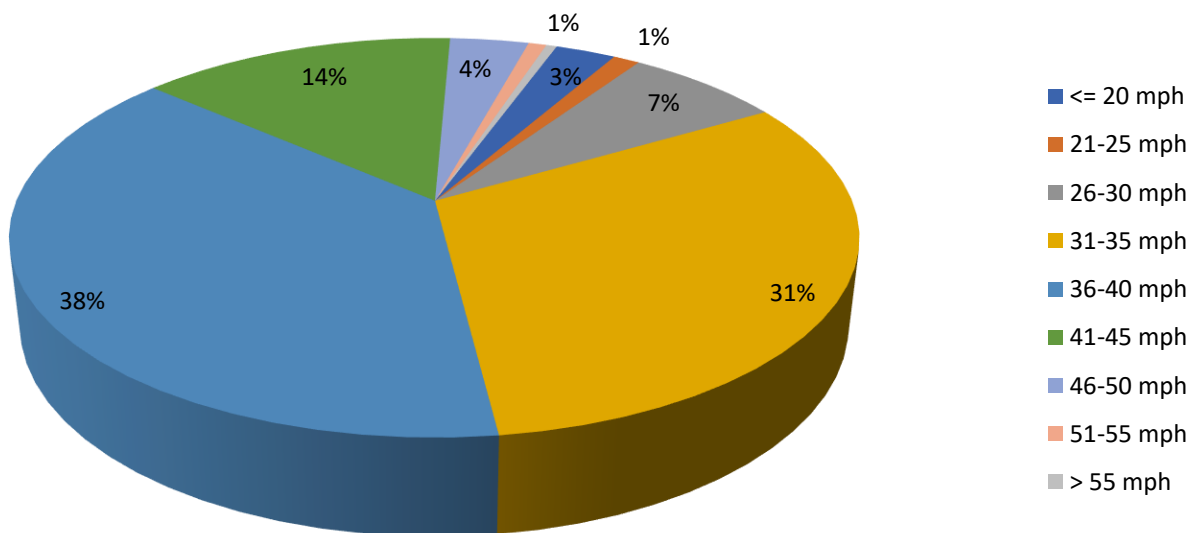
This diagram shows the distribution of vehicle speeds departing towards Somersham:

Vehicles departing towards Somersham

(The speed of vehicles travelling in this direction is not displayed to the driver and so the presence of the SID is likely to be less of a deterrent.)

23% of all vehicles were travelling in excess of the 30 mph limit with almost one in six exceeding 42 mph. The average speed was 37 mph.

These figures represent a very slight deterioration from the figures recorded last June.
